Fuel Leak Simulation

**Dr. Michael R. Swain
University of Miami
Coral Gables, FL 33124**

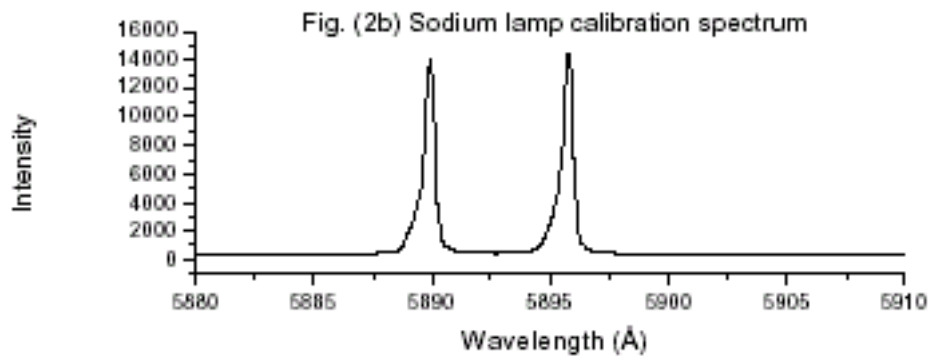
Figure (2a) shows a high-resolution spectrum of the 5890 Å feature taken with the 3/4 m spectrograph. Figure (2b) shows the spectrum of a high-pressure sodium lamp taken under identical conditions with the lamp in place of the flame. The high-resolution spectrum demonstrates unequivocally that the dominant flame emission is due to sodium D line emission. The characteristic D line doublet is due to emission from the excited 2P state and consists of the D1 line due to the ($^2P_{1/2} - ^2S_{1/2}$) transition at 5895.93 Å and the D2 ($^2P_{3/2} - ^2S_{1/2}$) transition at 5889.96 Å.

These results demonstrate that the dominant spectral feature in the visible region of the spectrum is due to sodium D line emission. This is due to particulate matter containing sodium that is entrained into the flame. The results also demonstrate that we can obtain high-resolution spectra of the OH radical, which may serve as an important flame diagnostic particularly of flame temperature. If the sodium emission is due primarily to thermal excitation, then the brightness of the sodium D line emission will depend on the diffusion flame temperature.

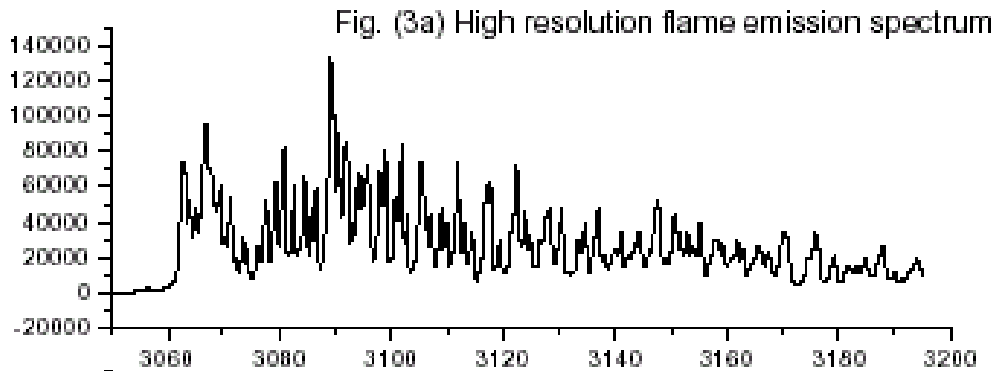
Figure (3a) shows a high-resolution spectrum of a portion of the 3000 Å feature. It can be seen that, in contrast to the sodium D lines we have a complex multi-line spectrum. This is characteristic of the spectrum of a simple diatomic or polyatomic molecule and the relatively open structure suggests a hydride. The strong emission spectrum of the OH A $^2\Sigma - X^2D$ (0-0) band lies in this region. This emission is characteristic of H_2/O_2 flames and has been extensively observed and characterized. A quantitative identification requires a computer simulation of the spectrum. Figure (3b) shows a simulation of the OH A-X (0-0) emission spectrum assuming a rotational temperature of 2800 K and a spectral resolution of 0.6 Å. The simulation clearly identifies the experimental feature as being due to OH. We have not attempted to identify the broad infrared spectral feature. Several sets of high and low-resolution spectra were obtained and this involved relighting the flame several times. It is an extremely turbulent diffusion flame

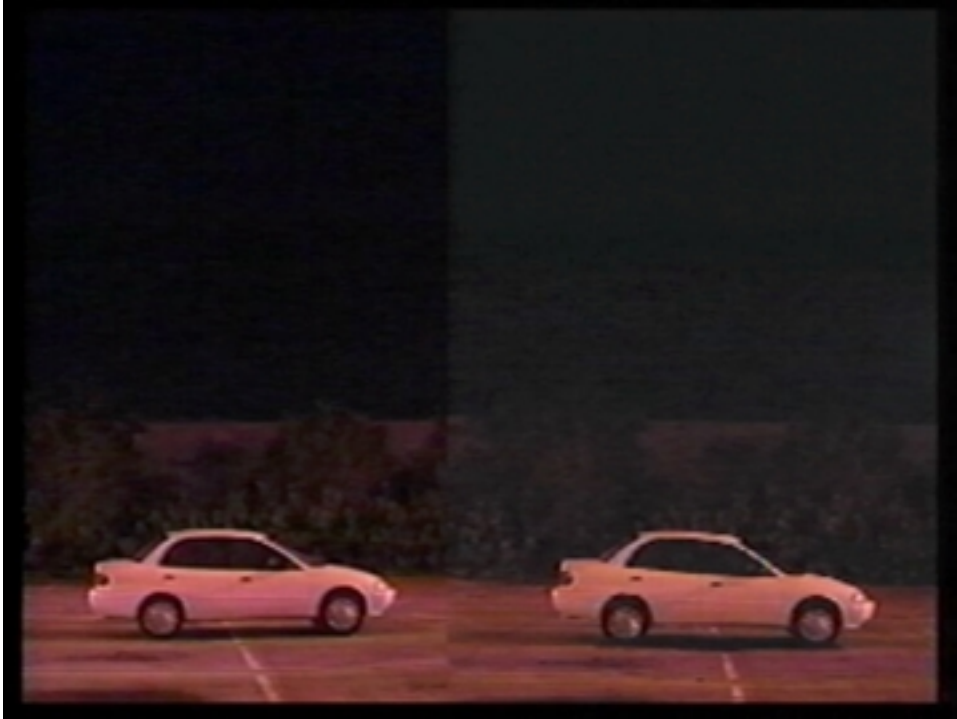
Photo 1 - Time: 0 min, 0 sec - Hydrogen powered vehicle on the left. Gasoline powered vehicle on the right.

The video was completed on schedule and was shown publicly March 5, 2001 at the NHA meeting in Washington. Eight frames from the video are included in the Appendix. At the NHA meeting, an oral narration was given with the video. The video simply depicts the single failure mode leakage and ignition of fuel from the two vehicles but, as of yet, has no narrative. It is felt a narrative describing in detail the accident scenarios for the two vehicles and perhaps some additional video footage of hydrogen fuel line leakage should be added before the video is presented to the public.

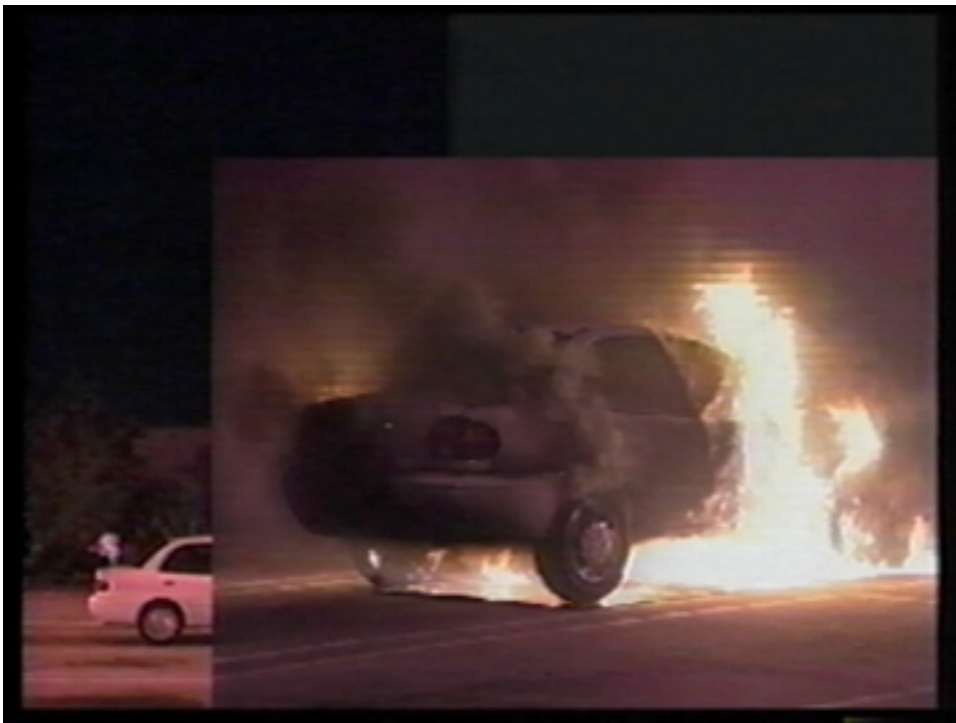
Photo 4 - Time: 1 min, 30 sec - Hydrogen flow almost finished. View of gasoline powered vehicle has been expanded to nearly full screen

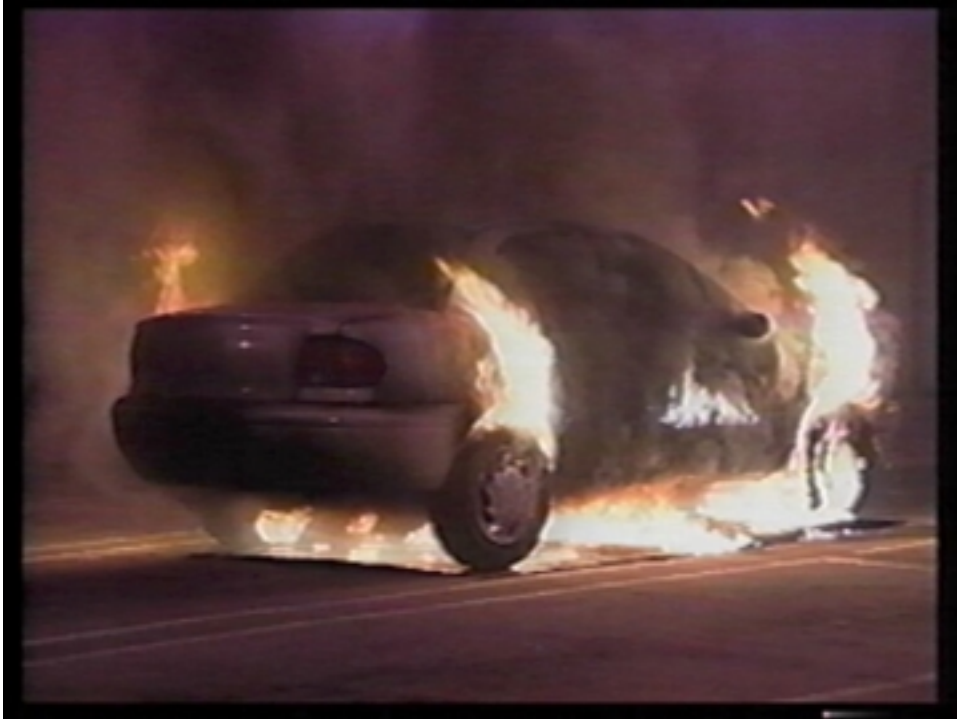
Photo 7 - Time: 2 min, 40 sec - Frame prior to driver's side rear tire rupture.

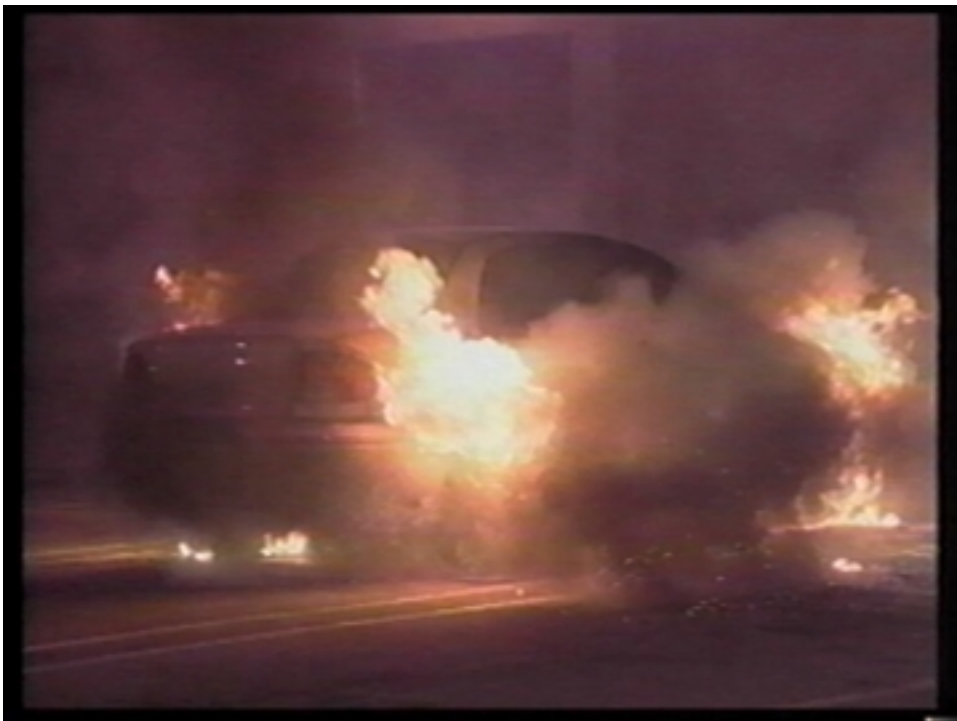
Photo 8 - Time: 2 min, 40 sec - Driver's side rear tire rupture sends debris out the passenger side of the vehicle.
